Mizen Head Footbridge

- Structural assessment of a historic ageing concrete through-arch structure
- Staged construction analysis of a new replacement bridge constructed during the sequential demolition of existing structure
- Winner of [Engineers Ireland Excellence Awards for Engineering Project of the Year 2011](#)

The new Mizen Head Footbridge is a reinforced concrete through-arch structure that spans 50m across a sea gorge to connect the island of Cloghán, at the tip of Mizen Head, with the mainland in South-west Cork, Republic of Ireland. [RPS Consulting Engineers Ltd.](#) used LUSAS Bridge analysis software to structurally assess an ageing a bridge that stood at the same location and to assist with the design and assessment of the effects of constructing a visually identical new replacement structure in stages around the original bridge at the same time as it was being sequentially demolished.

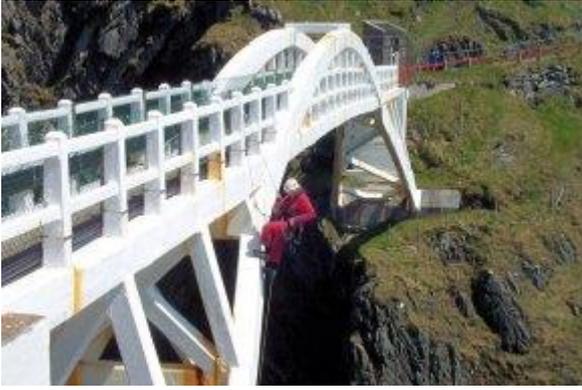
Inspection of original Mizen Head Footbridge

Whilst the bridge had been regularly maintained since its construction extreme weather and environmental conditions slowly took their toll. In 2000 an inspection by CIL engineers revealed areas of spalled concrete and reinforcement corrosion. In 2002, CIL appointed RPS (then M.C. O'Sullivan and Company Ltd.) to conduct a further inspection and in-depth structural assessment of the footbridge. RPS undertook material tests, observations and geometrical surveys to help establish the condition of the structure and to provide material and geometric parameters for use with maintenance, repair or strengthening scheme development. Defects noted during the inspections included rust staining, areas of hollow-sounding concrete, cracking and localised areas of missing concrete - all relating to corroding reinforcement. Various non-destructive and destructive tests were carried out on selected parts of the structure. These involved cover meter and hammer-tap surveys; chloride content testing; concrete core removal to derive equivalent cube strengths and for use with petrographic examinations; and localised breaking-out of concrete in the hangers to examine the condition of the reinforcement. In summary, very high chloride content levels were present throughout the structure which, whilst not affecting the integrity of concrete directly, provided a mechanism for reinforcement corrosion to occur. Based on the results it was concluded that the concrete, excluding the concrete in the cover zone, was of a sound nature.

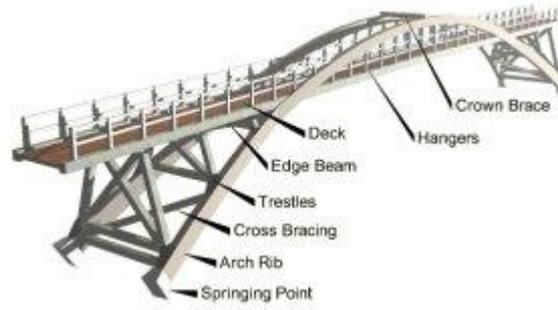
Structural elements of the bridge

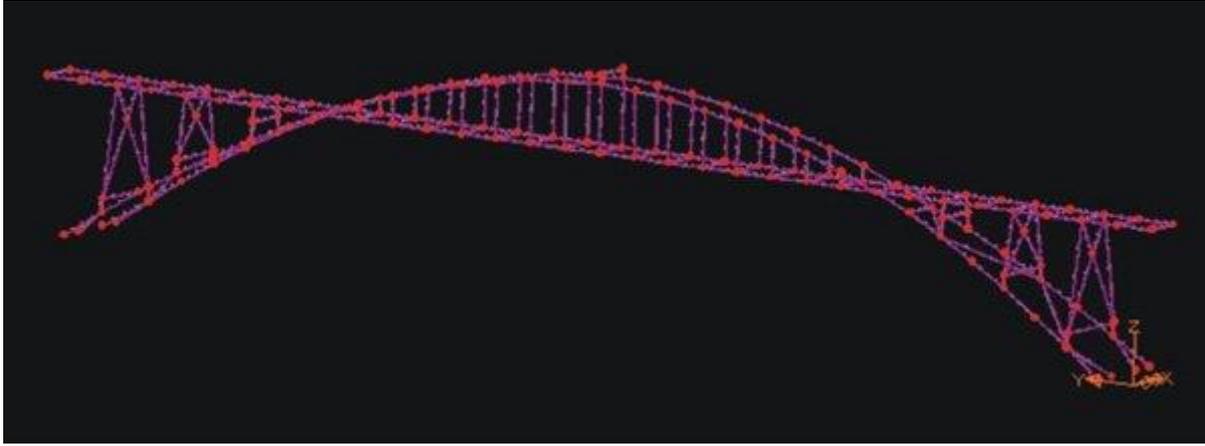
LUSAS Model of Original Mizzen Head Footbridge

Based on the original construction drawings and the information gathered during the principal inspection, RPS carried out a finite element assessment of the structure using LUSAS. Structural member stiffnesses were calculated neglecting the cover layer concrete. Structural member resistances were calculated using half the reinforcement as indicated in the construction drawings. The results indicated that the structure was still adequate for continued use due to good reserves of structural resistance to applied dead and live loading effects. However, because the central suspended span of the deck was relying on reinforced concrete hangers in direct tension and there was high chloride-induced steel corrosion throughout the structure, it was recommended that the hangers be strengthened and that measures be taken to halt the corrosion of reinforcement in the structure. A monitoring regime was set-up on the structure with inspections at six-monthly intervals.

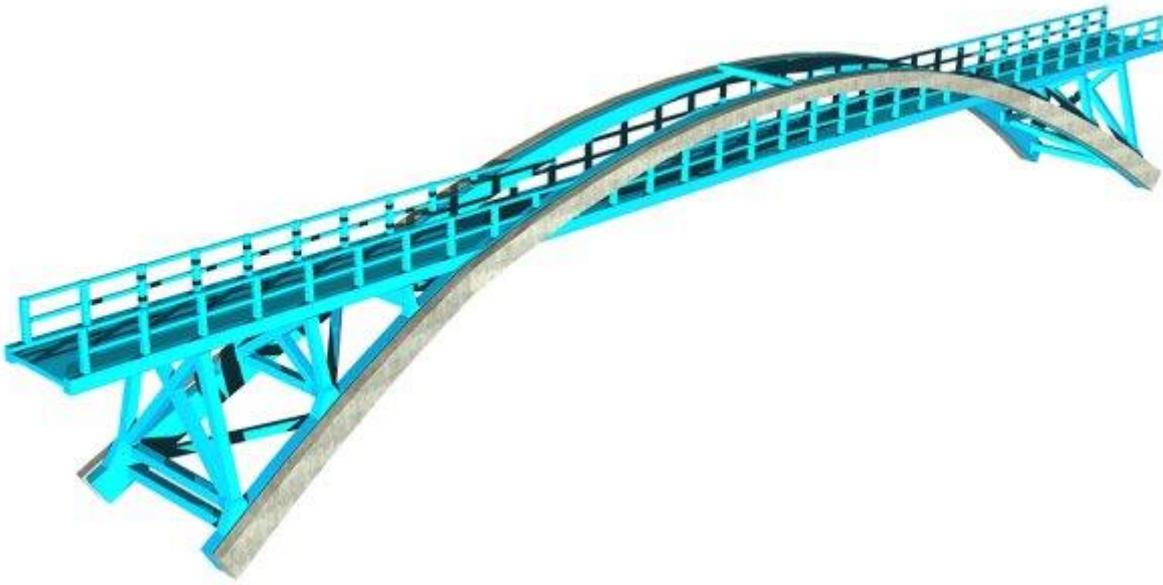
Construction of new arch ribs alongside original

After considering a number of total replacement options, the construction of a new two-pinned concrete arch bridge with a 120 year design life was eventually chosen. This client-preferred scheme produced a visual replica of the existing bridge and had the benefit of a 700mm wider deck. It required the initial construction of new arch ribs parallel to and outside the existing ribs, using the existing ribs (which were strengthened as required) as falsework. The sequential demolition of the existing bridge could then take place, followed by the construction of new trestles, edge beams, hangers and deck slab. Existing mass concrete foundations at the arch springing points and deck ends were retained, and stainless steel reinforcement was used throughout. A 52m long, temporary steel truss was used to span across and above the existing bridge deck to provide support to the main scaffold and act as a fail-safe for the various temporary works.

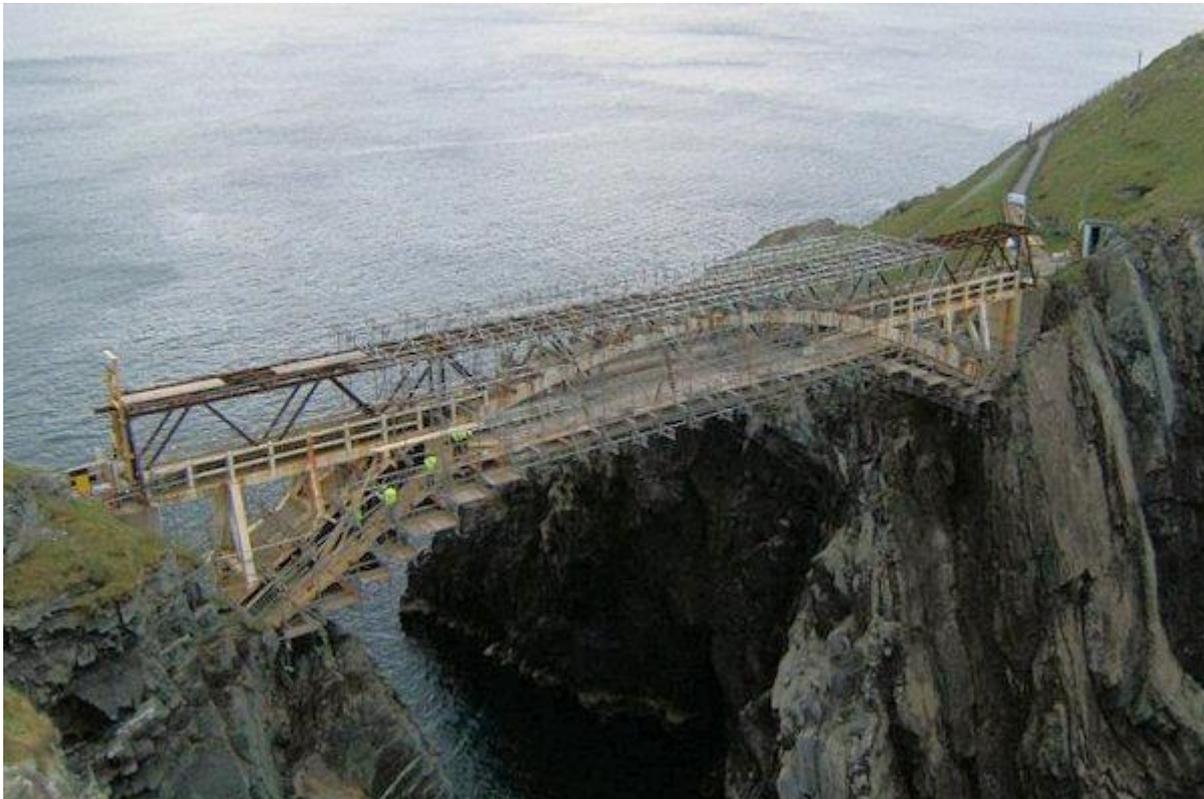
Mizen Head Footbridge showing access scaffold supported from temporary truss.
